PAE Operations and  
Maintenance Support  
at  
Embassy Kabul,  
Afghanistan

## Performance Evaluation

Report Number MERO-I-11-05, December 2010

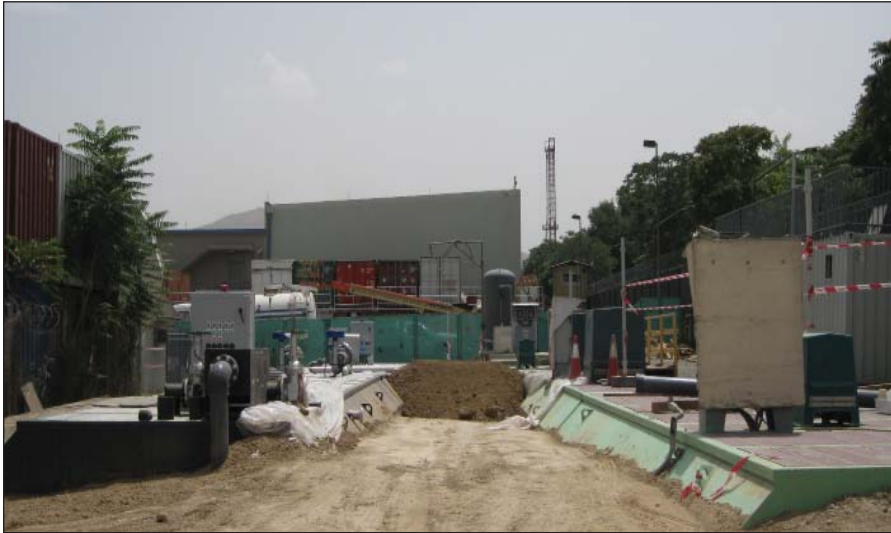
**Figure 3: This photo shows sewage tanks on Embassy Kabul's west compound.**

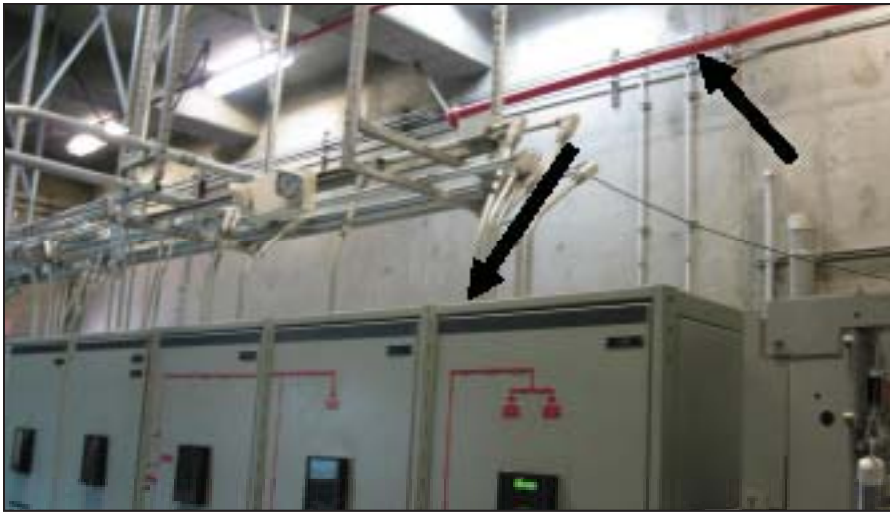
Although PAE has adequately maintained fire protection systems as required by its contract, OIG found a potential fire hazard in the embassy's west compound related to the location of sprinklers in the generator and control rooms. In comments on a draft of this report, OBO and the embassy dispelled OIG's initial concerns regarding the water pump that powers the fire compression system in the west compound. Embassy fire protection systems include all primary facilities and accessory systems in the interiors of buildings, fire alarms inside buildings, compound encompassing sprinklers and piping systems, the compound fire main from the diesel fire main pumps to the interior of the buildings, and fire hydrants. The embassy pays PAE \$226,595 annually for fire protection systems maintenance services. PAE has completed all required monthly preventive maintenance tasks contained in the contract's reliability-centered maintenance plan.

According to the PAE power plant supervisor, there could be a fire hazard at the embassy's west compound in the generator and control rooms where several transformers, transfer switches, converters, and other electric gear—the switchgear—are exposed to overhead sprinklers. In particular, fire suppression pipes with sprinklers are located over the 15,000-volt switchgear in the power plant. Should the sprinklers activate, water, a conductive substance, would fall directly on the live switchgear, which could lead to an explosion. An OBO fire protection systems official agreed that fire sprinklers should not be installed directly over the switchgear footprint, but contended that these sprinkler locations meet the National Fire Protection Association's *NFPA 13: Standard for the Installation of Sprinkler Systems*.

Figure 4: This photo shows the sprinkler system (up arrow) above the switchgear (down arrow) in the west compound.

**Recommendation 10:** Embassy Kabul, in consultation with the Bureau of Overseas Buildings Operations, should determine whether the location of fire suppression sprinklers over the high voltage switchgear in the power plant is a potential fire hazard that needs to be addressed. (Action: Embassy Kabul, in consultation with OBO)

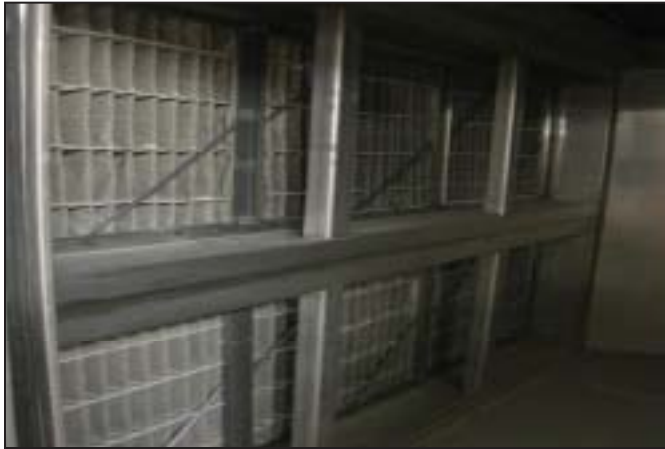
**Figure 5: This photo shows pre-filters inside a heating and air conditioning unit.**
