SIGAR 16-22 Inspection Report

Department of Defense Reconstruction Projects: Summary of SIGAR Inspection Reports Issued from July 2009 through September 2015

MARCH
2016

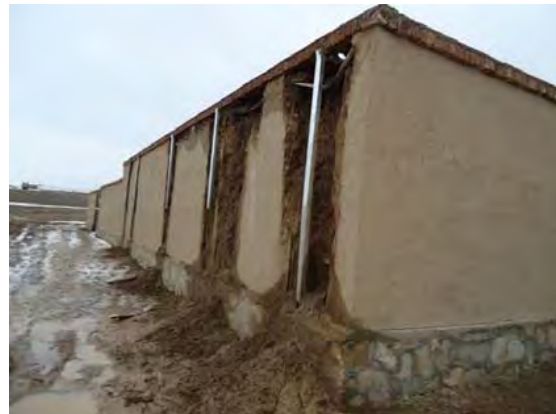
We reported that within 4 months of completion, the Afghan Special Police Training Center's dry fire range buildings began to disintegrate. This nearly \$500,000 project in Wardak province was administered by the Regional Contracting Center at Forward Operating Base Shank. Photo 1 shows the disintegration of one of the buildings. This disintegration or "melting" was caused by Qesmatullah Nasrat Construction Company, an Afghan firm, failing to adhere to contract requirements and international building standards, and using substandard materials. We also found that construction was plagued by poor government oversight throughout all phases of the project. Specifically, the contracting officer's representatives failed to identify any construction deficiencies. Further, despite the deficiencies, the Regional Contracting Center accepted the facilities and failed to hold the contractor fully accountable for correcting those deficiencies before the contract warranty expired. As a result, the range's safety and long-term sustainability were compromised. The Afghan government had to demolish and rebuild the dry fire range using its own funds, resulting in a waste of U.S. taxpayers' money.

Photo 1 - Exterior View of Building Deterioration Due to Water Penetration

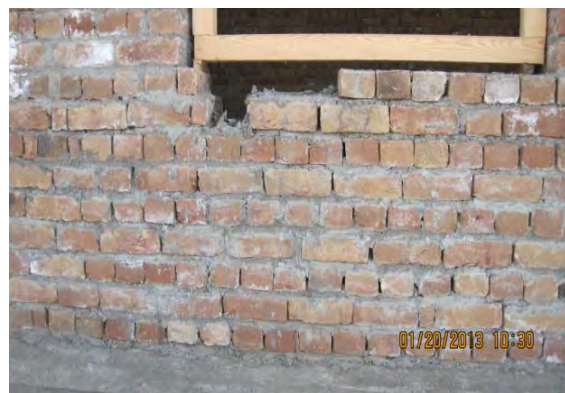
We reported that the Bathkhak School facility, which was under construction in Kabul province at the time of our inspection in 2013, was not being constructed in accordance with contract requirements. For example, instead of a single-story, 10-classroom building, we found two 5-classroom buildings were being built under this USFOR-A-administered project. We also found that the contractor substituted building materials without USFOR-A approval. In one instance, a concrete slab roof was installed instead of a wood-trussed roof, as required by the contract. This raised concerns because the school, which was to be occupied by hundreds of faculty and students, was located in an area of high seismic activity. Further, we found that the school appeared to have construction flaws that could compromise its structural integrity. For example, we found (1) large gaps between bricks in the walls that supported the concrete roof (see example in photo 2);

Photo 2 - School Building's Exterior Brick Wall with Gaps in Mortar

(2) walls that did not appear to be reinforced; and (3) honeycombing, exposed rebar, and concrete form boards remaining in the concrete slab roof.¹⁷ We also found that USFOR-A did not make its first oversight visit to the project site until 6 months after construction began. At that time, the school was 70 percent complete.

Responding to a draft of our inspection report, USFOR-A ordered personnel to have the contractor fix the deficiencies under warranty; however, the unauthorized concrete roof remained an uncorrected problem. USFOR-A's response stated that "a licensed structural engineer from the U.S. Army Corps of Engineers performed a building structural assessment to include test and analysis for determination of the structural integrity of the building. The engineer determined that the ceiling reinforcing may be inadequate and should be monitored for any future cracks." The response also stated that U.S. officials would meet with Afghan authorities to see whether they would accept the risk of the school structure "as is" and, if so, would advise them to monitor the school for cracks.

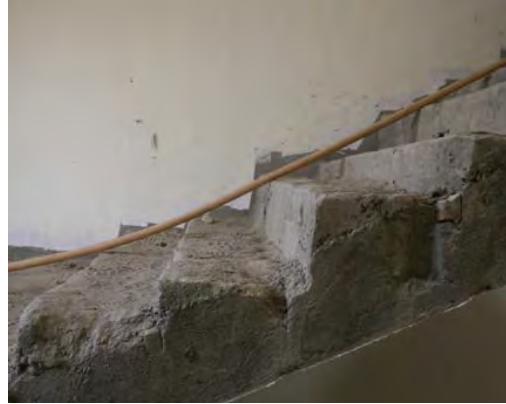
In October 2010, we reported that construction at each of the six district headquarters being built under a \$5.9 million USACE-administered project failed to meet contract and construction requirements. We found that the level of noncompliance at each site varied, but overall the construction was poor. Photo 3 shows stairs at the Garm Ser project site that are different heights and crumbling. Deficiencies identified were both extensive and unacceptable from a structural and safety standpoint. Problem areas included low-quality concrete and inadequate roofing installations. For example, inadequate concrete and foundation work called into question the structural integrity of the buildings and raised the risk of collapse. Most significantly, we observed structural issues that cast doubt on the facilities' ability to withstand an earthquake, as required by the contract. We also found numerous cases of product substitution in which lower-grade materials were used instead of the quality specified in the contract. For example, poor-quality residential-grade windows were used instead of the commercial-grade windows that are thermally insulated and tempered. Due to poor contractor performance and USACE's failure to implement its own quality assurance procedures, we concluded that the U.S. government might be responsible for \$1 million in repair costs to address the construction deficiencies we identified during our inspection.¹⁸

Photo 3 - Stairs of Different Heights and Crumbling at Garm Ser Site

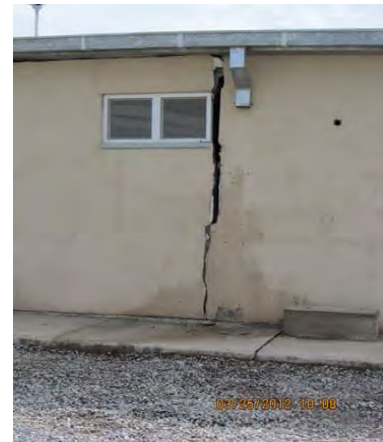
In 2010, we reported that several structures at the ANA garrison in Kunduz were unsafe, uninhabitable, or unusable. The structures were being built under a \$72.8 million contract administered by USACE. We observed severe ground settlement, roadbed cavities, and improper soil grading. We noted that the probable cause of these issues was a lack of adequate soil preparation and pointed out that soil problems were well known in the area. For example, German forces built a camp nearby and used soil replacement, elevated building pads, and drainage systems to counter the risk of collapsible soil. Our report stated, "To protect U.S. investment in the garrison and provide a functioning center for ANA troops currently housed in tents outside the garrison, the issues we observed—most critically, the soil settling and site grading—need to be addressed." However, in a 2012 follow-up inspection, we found that soil instability and structural failure of facilities continued to occur, with ANA soldiers now living on the compound. For example, we found a latrine building that had settled and cracked, and was unusable

Photo 4 - Cracked Exterior of Latrine Building at ANA Garrison in Kunduz

(see photo 4). USACE officials attributed it to water infiltration underneath the building. An adjacent barracks was beginning to settle and was at risk of structural failure. We also found a sinkhole and pooled storm water putting the concrete pad for a transformer that provided much of the base's power at risk of structural failure.

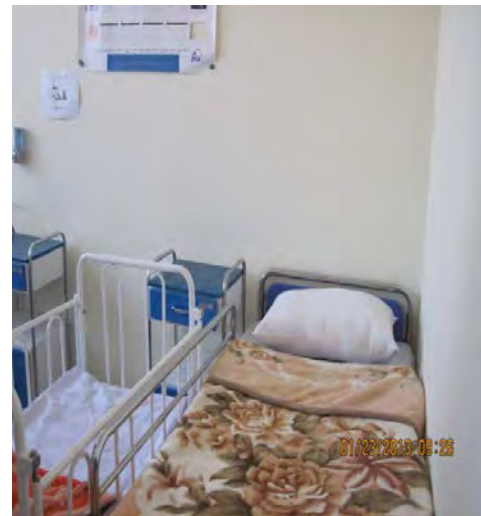
We did not observe any major deficiencies, and our inspection found that the clinic had working heat, electrical, and water systems; floors were clean; medical staffing was good; bedding was plentiful and well kept; and the separate pharmacy building was well stocked. Photo 5 shows a postnatal room. Our report also noted that the Ministry of Public Health had signed an agreement as part of the approval process to sustain the clinic upon completion and that it had fulfilled its commitment to do so, and should be commended for it.

Photo 5 - Postnatal Room at Qala-i-Muslim Medical Clinic
