SUBJECT: U.S. Army Corps of Engineers (USACE) Status Update on SIGAR Inspection Report 13-1, Kunduz ANA Garrison: Army Corps of Engineers Released DynCorp of All Contractual Obligations Despite Poor Performance and Structural Failures

USACE Status Update on Recommendations 1 and 3 in SIGAR Inspection Report 13-1, Kunduz ANA Garrison: USACE Released DynCorp of All Contractual Obligations Despite Poor Performance and Structural Failures

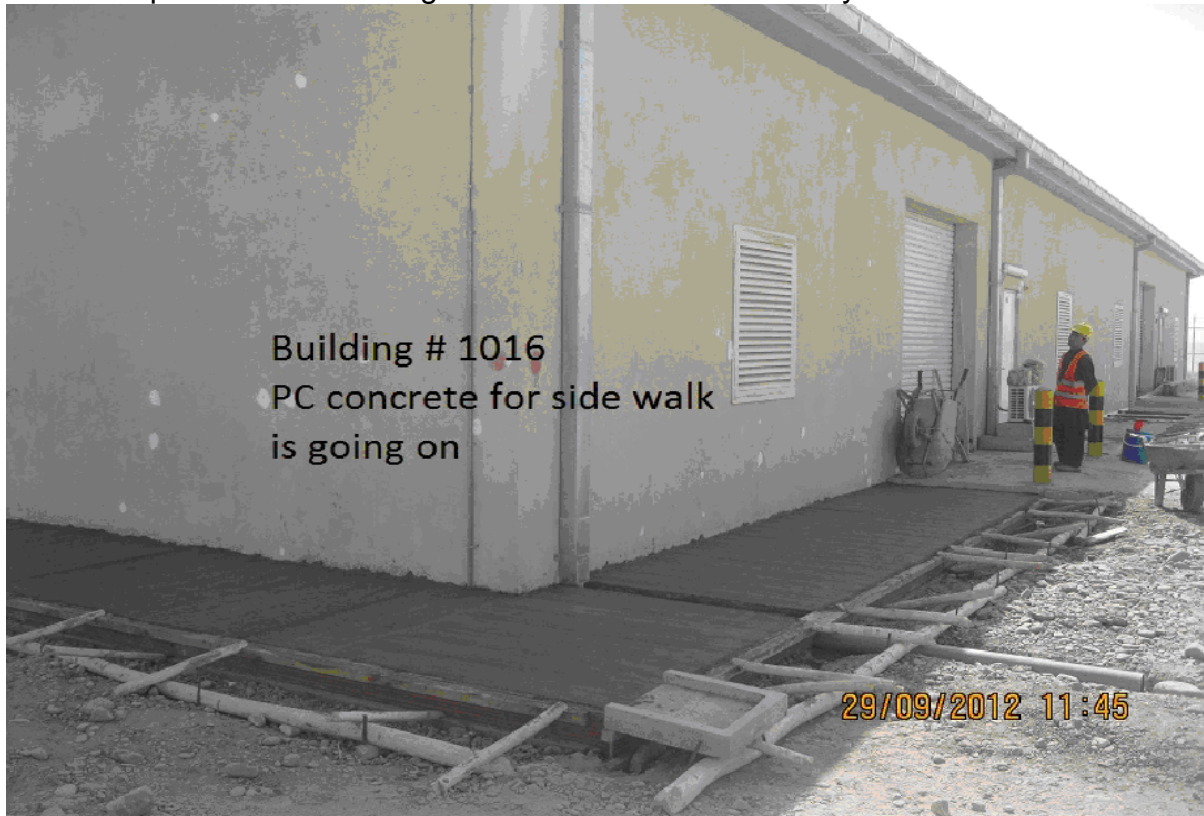
Picture 1- Sloped sidewalks being installed to divert water away from foundation.

Site Drainage: As part of the ANA Building Repair Contract (W5J9JE-12-C-0031), USACE is placing a 1.5 meter concrete apron or sidewalk around each building with a minimum slope of 0.5% away from the building. In addition, downspouts are being extended to a length of three meters away from the building. These drainage improvements were determined the best available method to prevent water from pooling around the buildings. This in turn minimizes the chance of structural failures. Picture 1 on the following page shows sidewalk with slope being installed around building # 1016.
